# National Transportation Safety Board

HWY22MH009

## **SIGNAL AND HIGHWAY FACTORS GROUP**

Group Chair's Factual Report

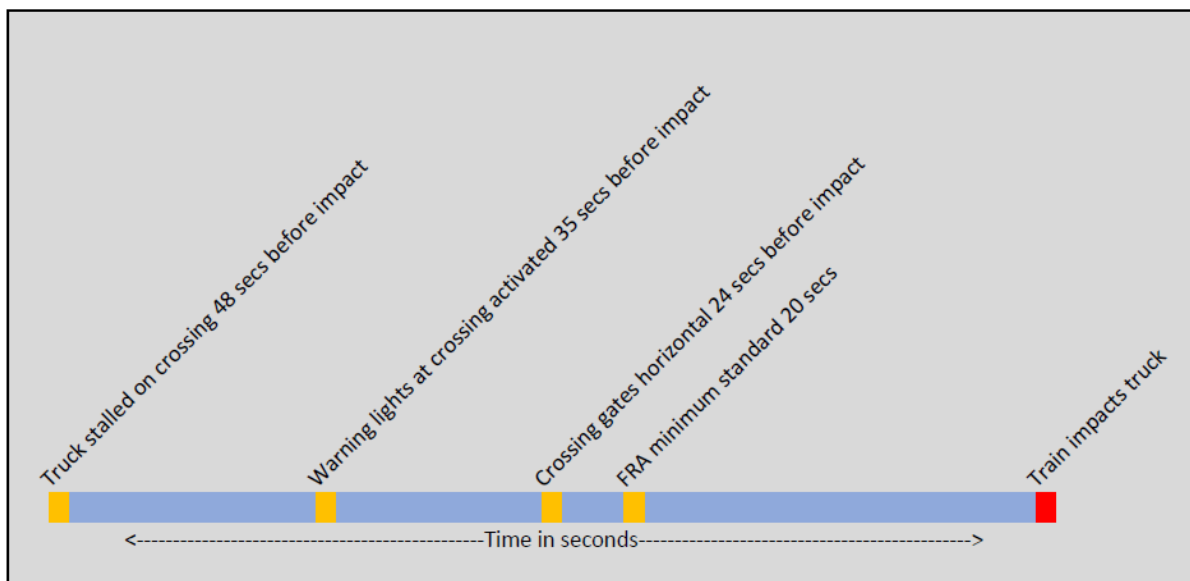
**Figure 3** - Timeline of the crash location from the approximate time the truck stalled on the tracks.

**Figure 3** illustrates the timeline of the crash location from the approximate time the truck stalled on the tracks.<sup>10</sup> The truck stalled approximately 48 seconds before impact. The crossing lights began to flash approximately 35 seconds before impact. The north gate was approximately horizontal 24 seconds before impact. The south gate was resting on top of the stalled truck. The data logs indicated that 35 seconds of warning time were provided, which is above the minimum warning time of 20 seconds required by the FRA standard and MUTCD.

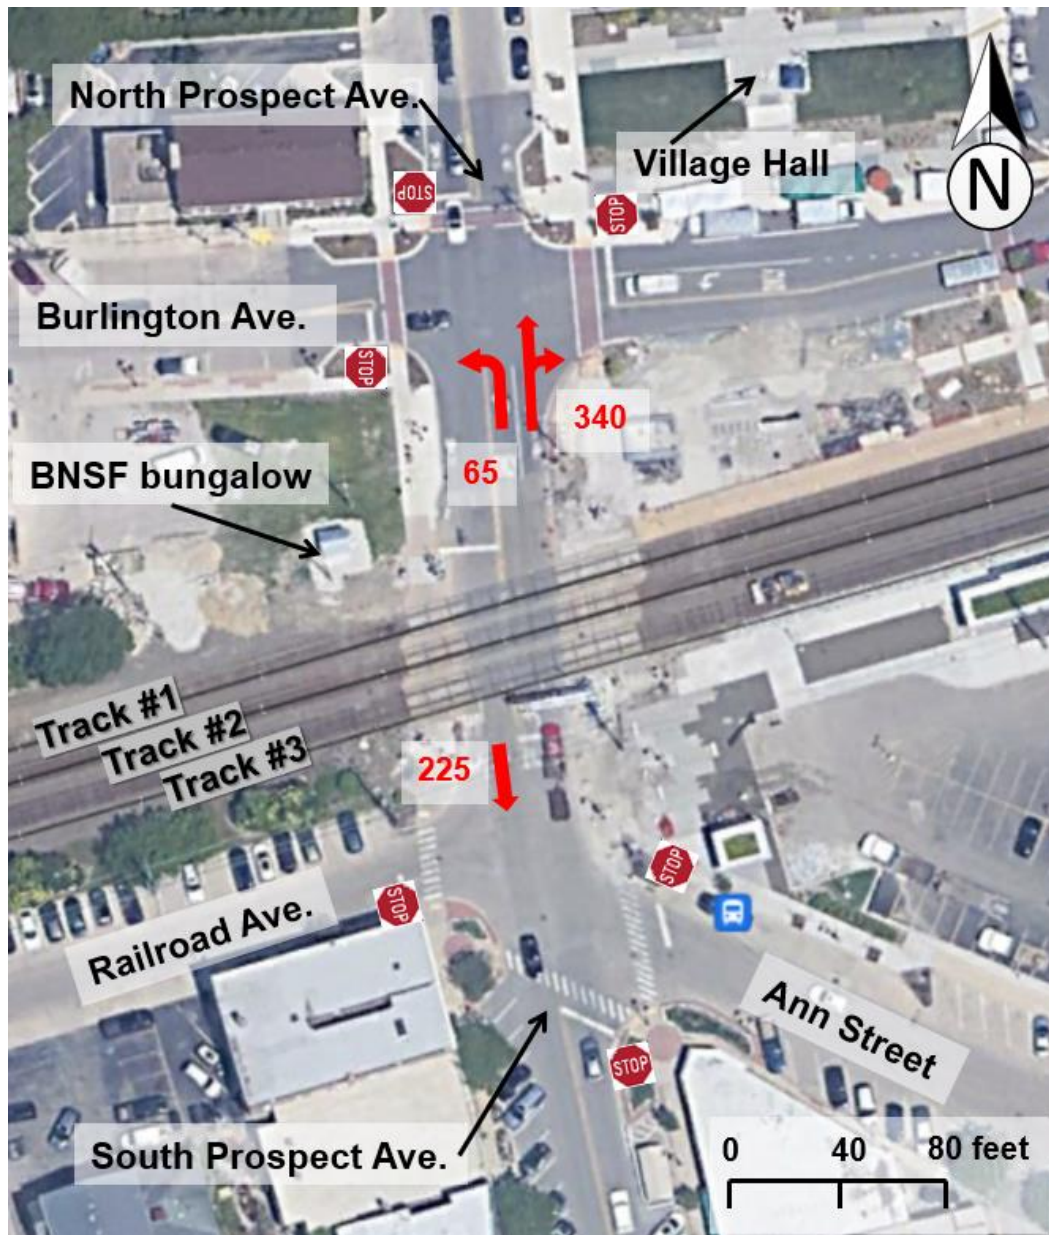
**Figure 4** - Geometry, signing, and peak hourly volumes near the grade crossing (Source: Google Earth revised, imagery date 4/24/2021).

**Figure 4** illustrates the geometry, signing, and peak hourly volumes near the grade crossing. Free flow operation existed in the northbound direction at the intersection of North Prospect Avenue and Burlington Avenue.<sup>14</sup> The northbound direction consisted of left turn peak hourly volumes of 65 vehicles and thru-right turn peak hourly volumes of 340 vehicles.<sup>15</sup> Stop signs existed at the other 3 quadrants of the intersection. In addition, free flow operation existed in the southbound direction at the intersections of South Prospect Avenue and Ann Street/Railroad Avenue with peak hourly volumes of 225 vehicles. The free flow operation helped to avoid queuing and back-up of vehicles on the grade crossing.

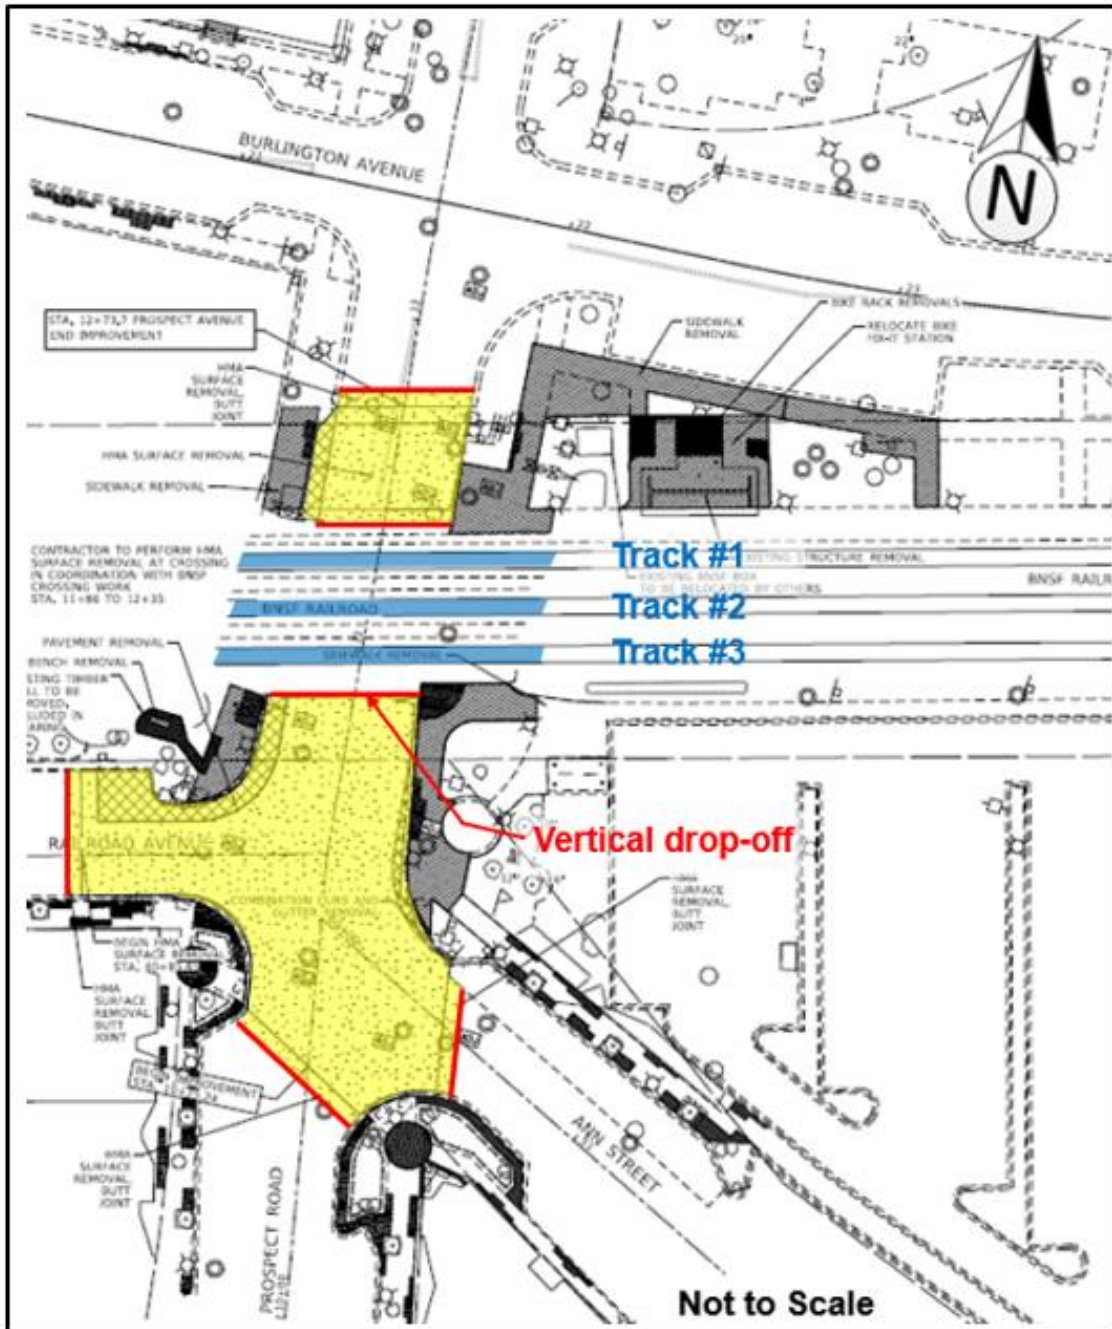
**Figure 5** - Plan view of Village of Clarendon Hills streetscape and paving improvements (Source: Village of Clarendon Hills revised).

The yellow highlighted area in **Figure 5** illustrates the plan view of the Village of Clarendon Hills streetscape and paving improvements in the vicinity of the grade crossing.<sup>16</sup> The project was approximately 95% complete at the time of the crash. Items remaining to be completed included final paving, pavement markings, crosswalks, and manhole frame adjustments. The profile view of Prospect Avenue in **Figure 6** illustrates the roadway grade leading up to the crossing at the south and north ends.

The roadway grade leading up to the south end of the grade crossing was approximately a positive 6 percent grade. The red lines shown in **Figures 5 and 6** indicate locations where vertical drop-offs existed that ranged from approximately 1.5-inches to 2-inches. The American Association of State Highway and Transportation Officials (AASHTO) A Policy on Geometric Design of Highways and Streets recommends the surface of the roadway should not be more than 3 inches lower than the top of the nearest rail at a point 30 feet from the rail as shown in **Figure 6**.<sup>17</sup> No low ground clearance signs were used at the grade crossing because all overweight/oversize loads require a permit from the Village of Clarendon Hills. All overweight/oversize loads are directed to use the Village of Clarendon Hills Truck Route as shown in **Figure 9** that illustrates a grade separation of the IL 83 and BNSF triple main track.

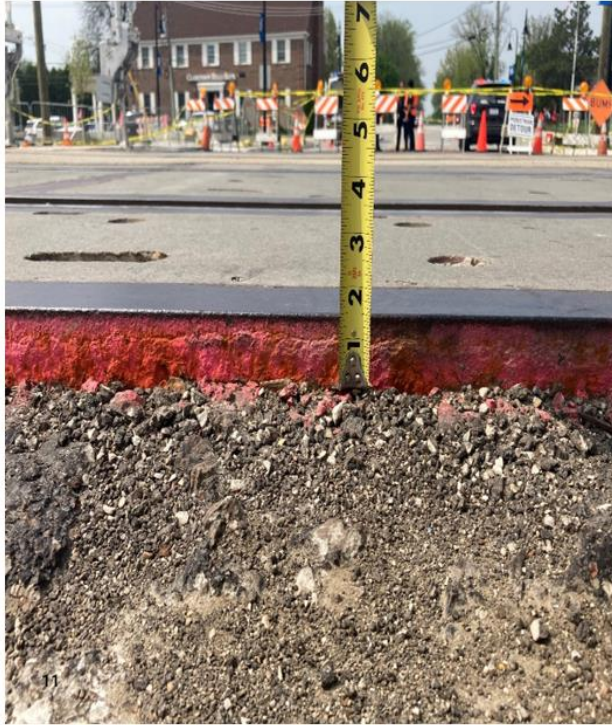
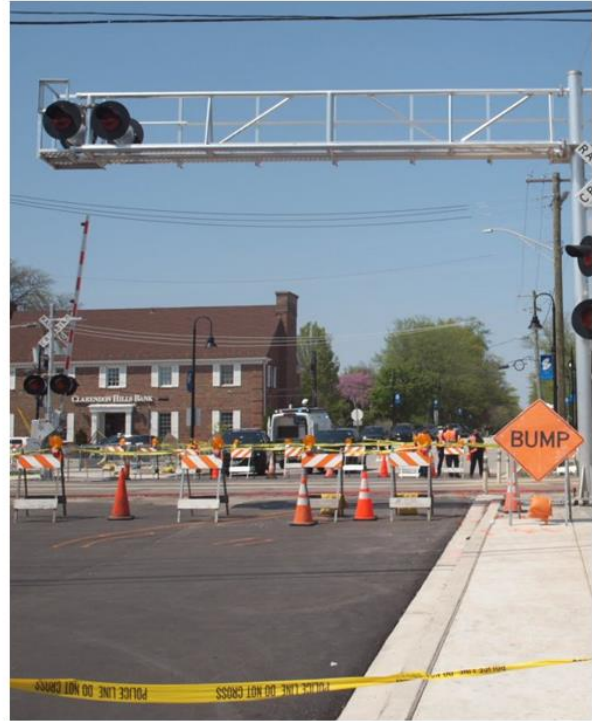
**Photographs 1 and 2** - Vertical drop-off at the south end of the grade crossing in the northbound direction (Source: Illinois Commerce Commission).

The photograph to the left, **Photograph 1**, illustrates a vertical drop-off at the south end of the grade crossing in the northbound direction that was approximately 1.5-inches. The photograph to the right, **Photograph 2**, illustrates a “bump” sign which existed at the time of the crash warning drivers of the vertical drop-off in the northbound direction. The Illinois Department of Transportation (IDOT) standard for vertical drop-offs are included in the IDOT Standard Specifications.<sup>18</sup>

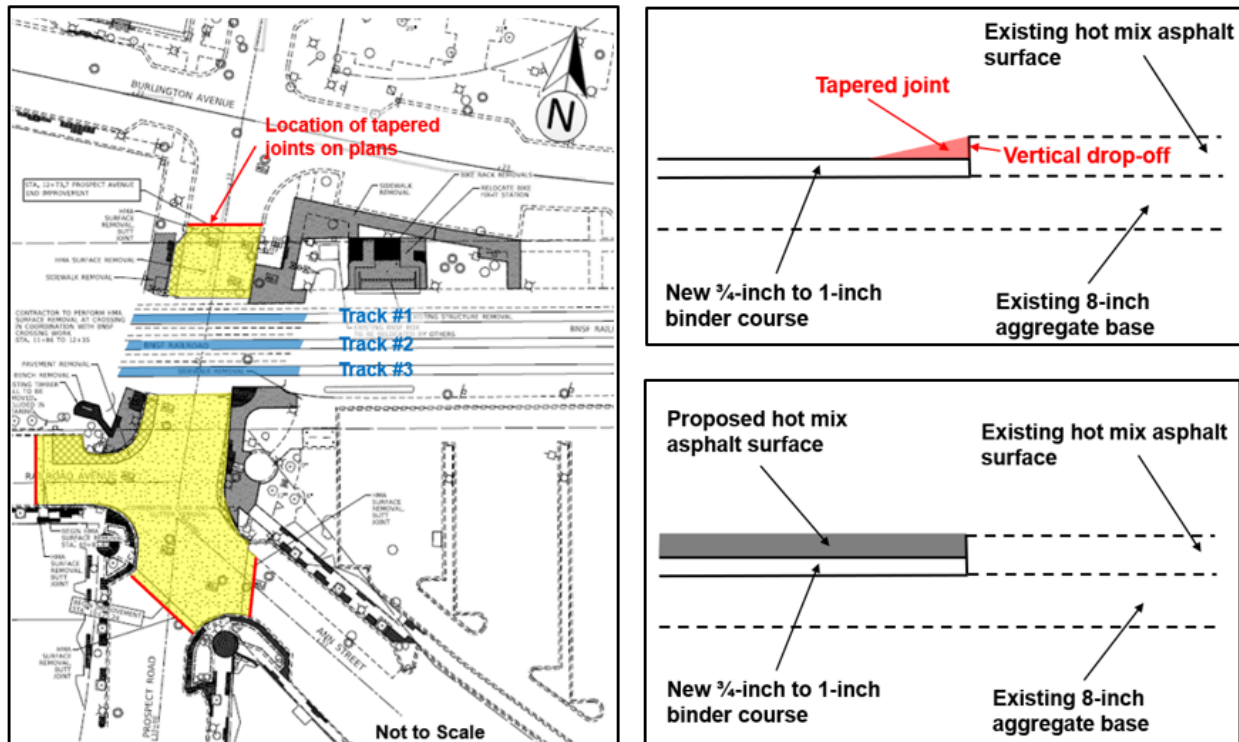
**Figure 7** - Location of tapered joints on the streetscape and paving improvements plans (Source: Village of Clarendon Hills revised).

The illustration to the left of **Figure 7** shows the location of tapered joints on the streetscape and paving improvements plans.<sup>19</sup> A tapered joint, as shown in the upper right portion of **Figure 7**, is a temporary ramp constructed and maintained at both the upstream and downstream ends of the surface removal areas.<sup>20</sup> No tapered joints were constructed in the vicinity of the grade crossing or at the locations shown on the streetscape and paving improvements plans at the time of the crash. A tapered joint is typically removed, as shown in the lower right portion of **Figure 7**, immediately before the application of the hot mix asphalt surface.

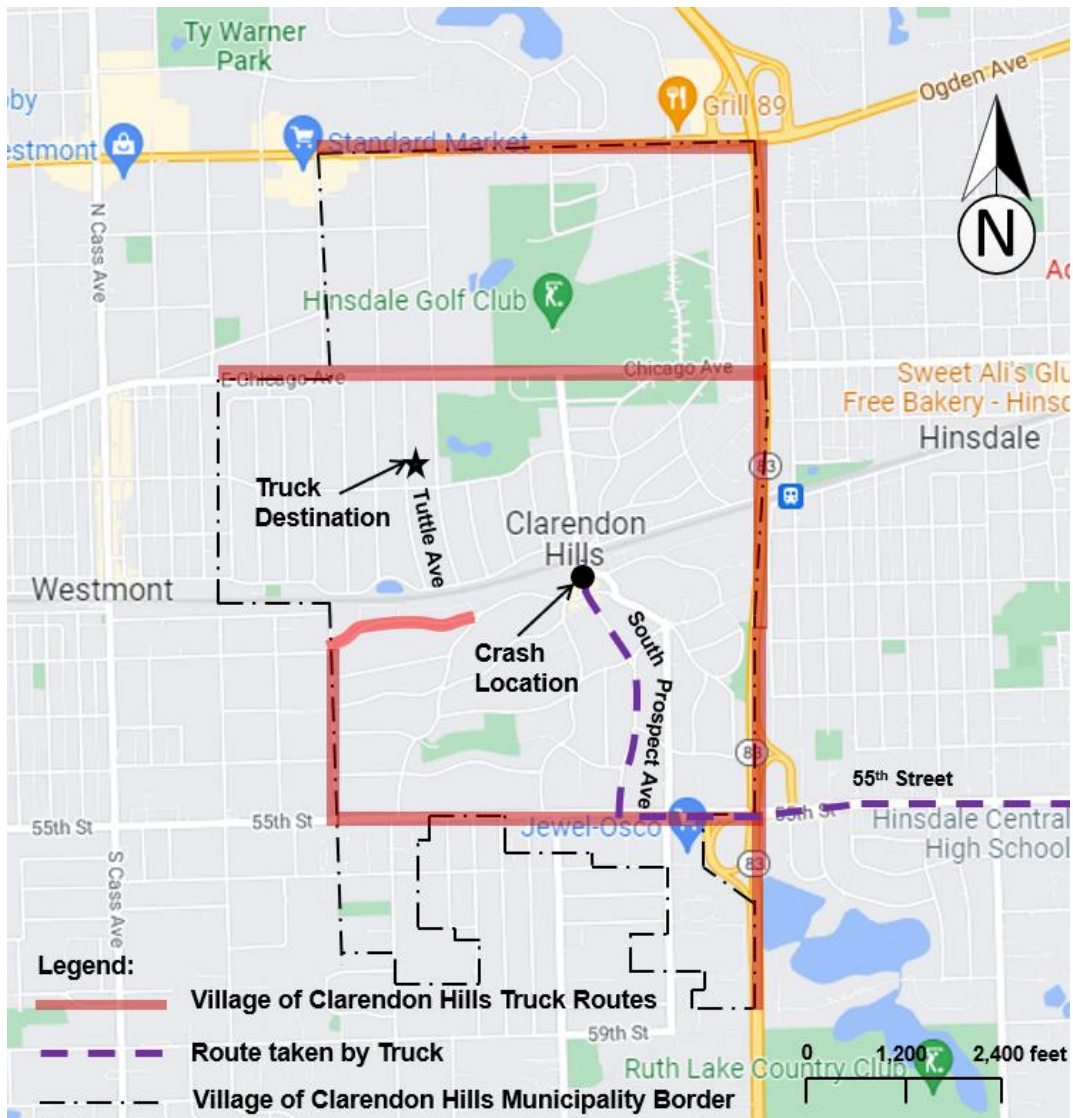
**Figure 9** - Village of Clarendon Hills municipality border, designated truck routes, and route taken by the truck involved in the crash (Source: Google Maps revised).

**Figure 9** illustrates the Village of Clarendon Hills municipality border, designated truck routes, and route taken by the truck involved in the crash.<sup>26</sup> The Village of Clarendon Hills indicated the following in an email to NTSB investigators.<sup>27</sup>

The route provided by the GPS did not contemplate designated truck routes. As a result, the driver was in violation of Chapter 50 when he left 55th Street to South Prospect Avenue. Village regulations require any vehicle, which is greater than 16,000 pounds or rated greater than 16,000 pounds making a delivery or pick up in the Village to use the most direct route from the closest nonrestricted street to the particular delivery or pick up site.<sup>29</sup> 55th Street to South Prospect Avenue was not the most direct route to the Tuttle Avenue destination. To be in compliance with Chapter 50, the most direct route, from the closest nonrestricted street, would be to access Tuttle Avenue from Chicago Avenue. The destination was less than one block from Chicago Avenue, a nonrestricted street in the Village of Clarendon Hills.
